Model NR3EC

Pressure Reducing Valve with Integral By-pass and Pressure Relief Valve
(1/2", 3/4" & 1")

REPAIR KIT INSTRUCTIONS

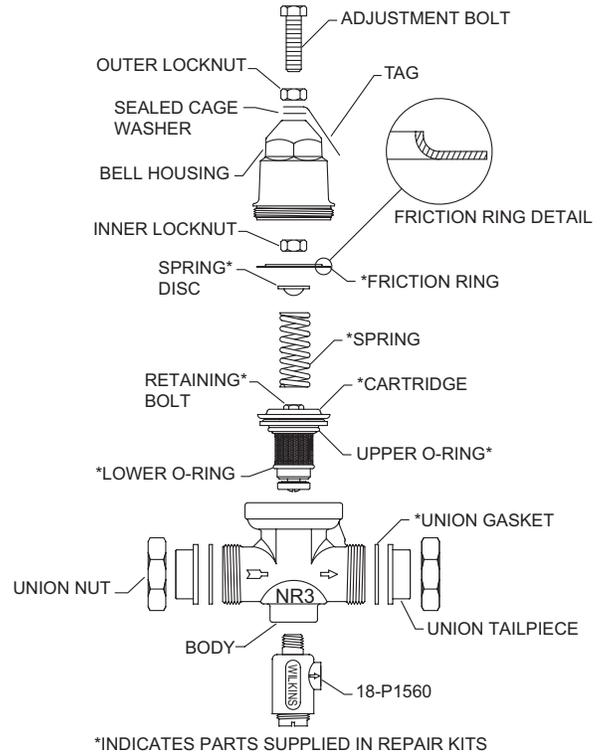
1. Note distance that adjustment bolt protrudes from bell housing. Loosen locknut on adjustment bolt, then turn adjustment bolt out of bell housing until free of spring tension.
2. Unscrew bell housing counterclockwise and remove spring, spring disc and friction ring.
3. Remove cartridge from regulator by gripping retaining bolt with pliers and pulling outwards away from body.

1. Open shut-off valve slowly and flush body and line of any debris.
2. Replace old cartridge assembly with new cartridge assembly. Prior to installation, apply a small amount of lubricant to cartridge o-rings. The cartridge is pushed into bore on body and seals against o-rings.

3. Install new spring, spring disc and friction ring. Make sure friction ring is installed with raised edge facing up (friction ring detail).
4. Replace bell housing by tightening clockwise (Be sure not to over-tighten.). Turn adjustment bolt clockwise until adjustment bolt touches spring disc.

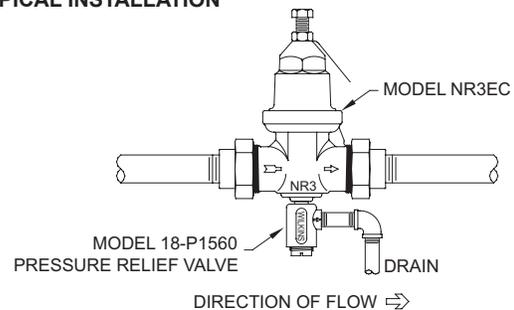
TYPICAL INSTALLATION

Install valve in line with arrow on valve body pointing in direction of flow. Before installing reducing valve, flush out line to remove loose dirt and scale which might damage seal ring and seat. All valves will be furnished with stock settings to reduce to 50 psi. To readjust reduced pressure, loosen outer locknut and turn adjustment bolt clockwise (into bell housing) to raise reduced pressure, or counterclockwise (out of bell housing) to lower reduced pressure.

WARNING: Attach drain line to relief valve and plumb to a safe location. The drain line should terminate at a location where discharge of water will not cause damage or general discomfort.

Regulators in series: Where the desired pressure reduction is more than a 4 to 1 ratio (i.e. 200psi to 50psi), multiple regulators in series should be installed.
